# EVALUATION OF PROCESSES ON THE COAST OF THE WATER RESERVOIR THROUGH SPACE SURVEY (ON THE EXAMPLE OF CHIMKURGAN RESERVOIR)

This article examines the changes in the shores of the reservoir, the geological conditions and the factors influencing it, based on observational data obtained from the shores of the Chimkurgan Reservoir through space surveys of the reservoirs. Based on the study, the geological condition of the coast was determined. Known areas were selected according to the formation of coastal rocks and changes in them were studied.

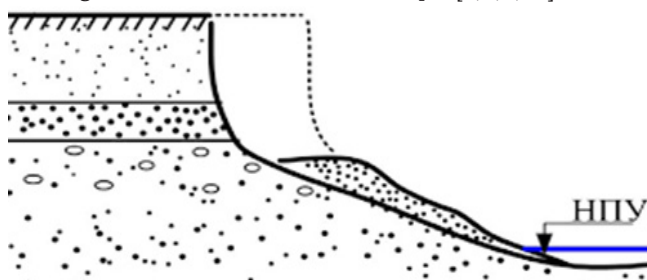
**Figure 1. The movement of soils during landslides that occur on the banks of reservoirs**

When the banks of the reservoir were surveyed, it was found that landslides occurred as a result of insufficient adhesion of the soils. For this reason, we can see that there are very large landslides on the banks of the reservoir, and in a short time the shoreline of the reservoir has undergone a great deal of change.

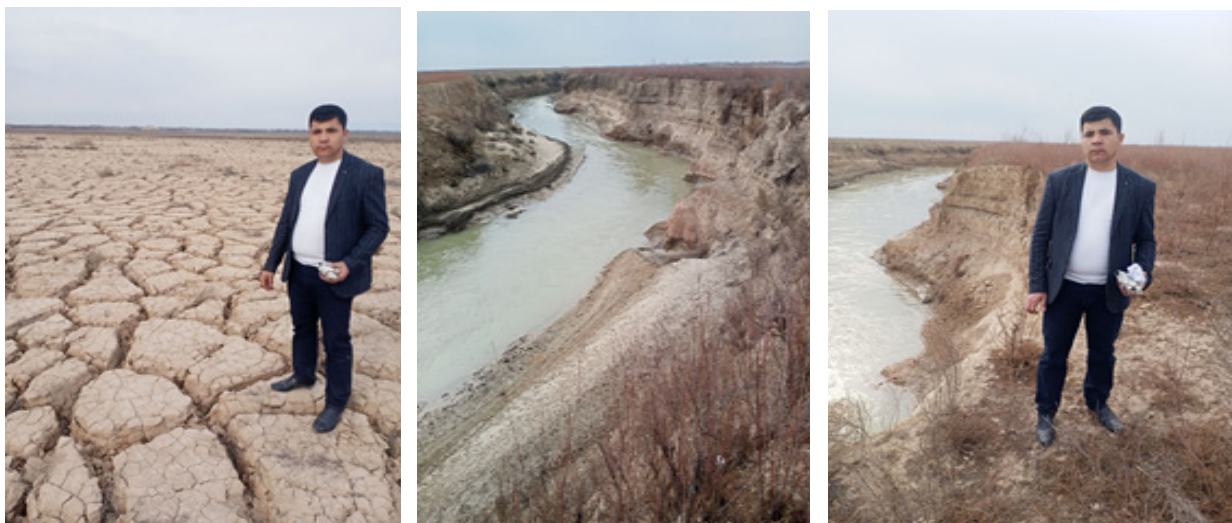
Figure 2. The process of sampling of soils on the banks of the Chimkurgan Reservoir

Soil analyzes taken from the reservoir shores show that medium sandy and heavy sandy soils have formed in the area, with a high susceptibility to water erosion.

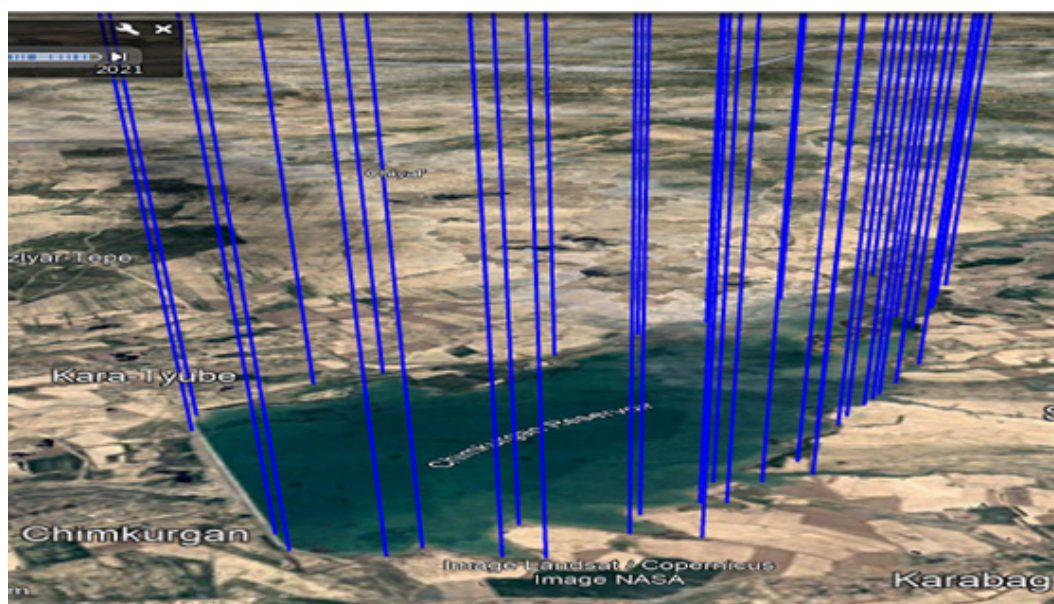
Figure 4. The coastal boundaries of the Chimkurgan Reservoir have been identified

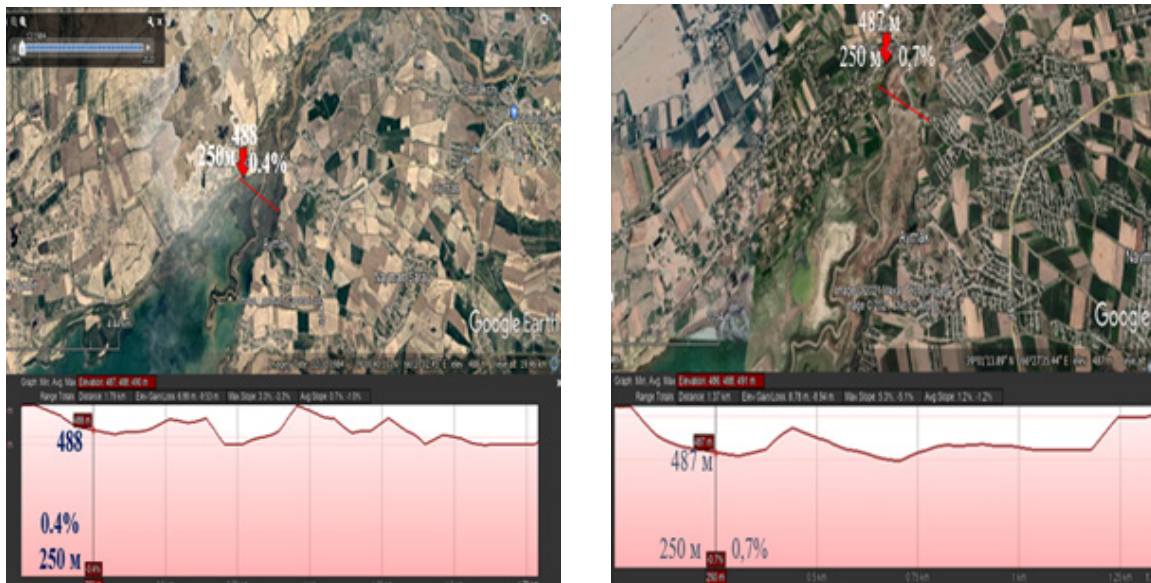
Figure 5. Figure 6 , December 1984. March 2020 coastal shape

**Conclusion.** The survey showed that the space survey of the Chimkurgan Reservoir was 488 meters above sea level in 1984 and decreased to 487 meters by 2022. During the observation period, there was a deepening and lateral erosion on the bank of the reservoir.
